# HMS Colossus Diver Trail Guide

## History

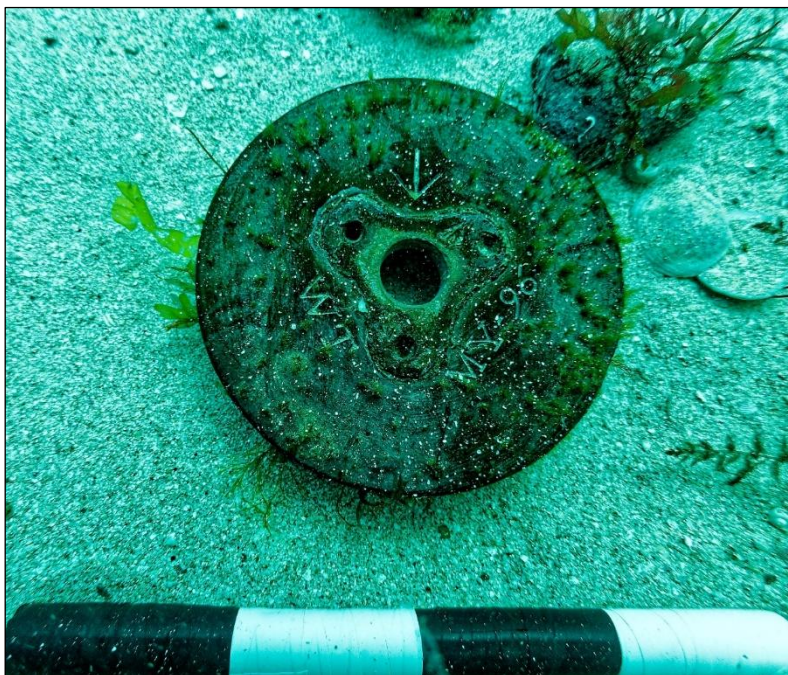
An example of the objects which can be seen on the seabed. This is a 5 inch wooden sheave pulley with copper alloy coake (bearing) – marked **WT** (Walter Taylor the manufacturer), **MY96** (May 1796 the date of manufacture), and the broad arrow ↑, a mark denoting government property. Photographed in 2023 near dive station 8.

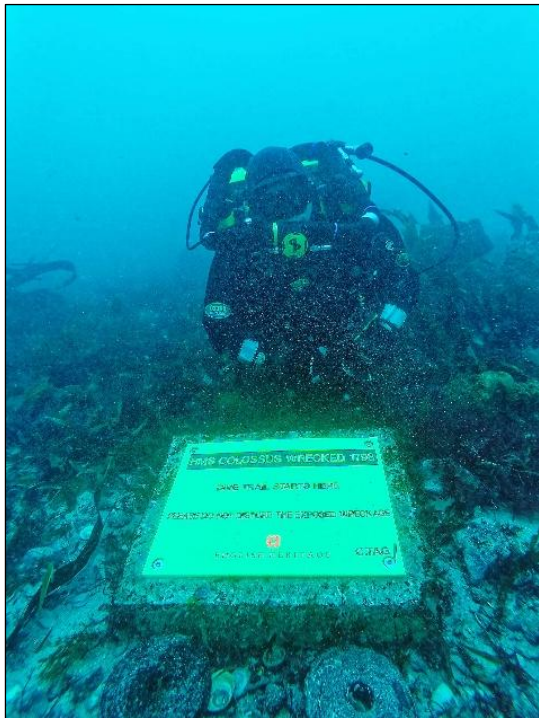
Here is the start of the diver trails at the seabed sign. The sign may have some marine growth covering the face – but even so is generally quite easy to spot. In front of you lies the stern of the wreck. To get to the first diver station you need to swim 5m to station number 1 – there is a bottom line to guide you.

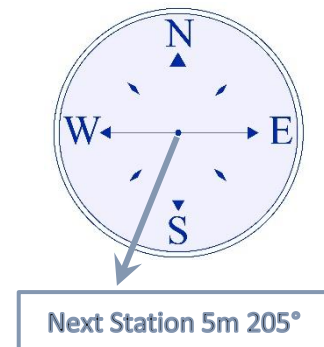
1

Here you can see the remains of several muskets. These were used by the 120 marines on board *Colossus*, as well as by the ordinary seamen. These are sea service muskets, similar to the well-known 'Brown Bess' of the British Army, but simpler and slightly shorter than the standard land musket. They were smooth-bore flint-lock weapons and fired a lead ball of 0.75 inch diameter. The accuracy of this type of weapon was low; the effective range would have been well under 100m. The barrel is made from steel, the stock is wood and the trigger guard and butt plate are copper alloy. To the north of the muskets are a number of large iron objects. These are the remains of the mizzen chains, the iron fastenings which held the shrouds (supporting ropes) which ran from the mizzen mast to the outside of the ship's hull.

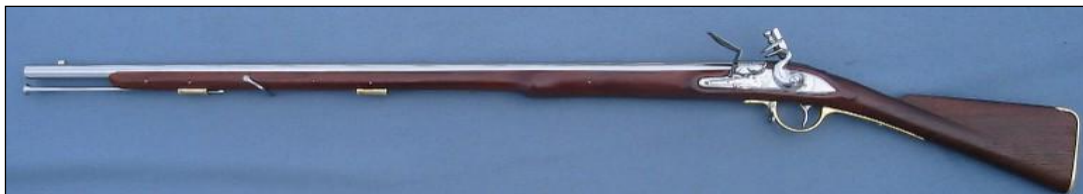
This is what the now corroded muskets would have looked like. The musket was fired using black powder (gun powder), which was ignited by sparks generated by a flint striking a steel plate.

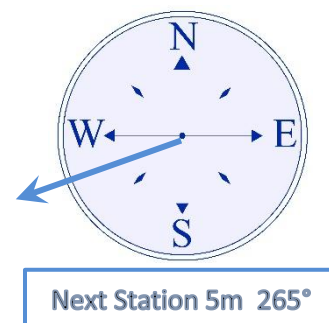
At station 2 you should be looking at what appears like a giant iron bollard sticking up from the seabed. This is one of the upper gun-deck 18-pound guns, standing where it crashed through its gun port when the ship fell onto its beam ends. Look carefully at the gun and you will see the remains of the iron bolts which held the wooden gun carriage together (the wood has rotted away but the iron bolts are still there). There is a row of six of these guns, and you will see them all.

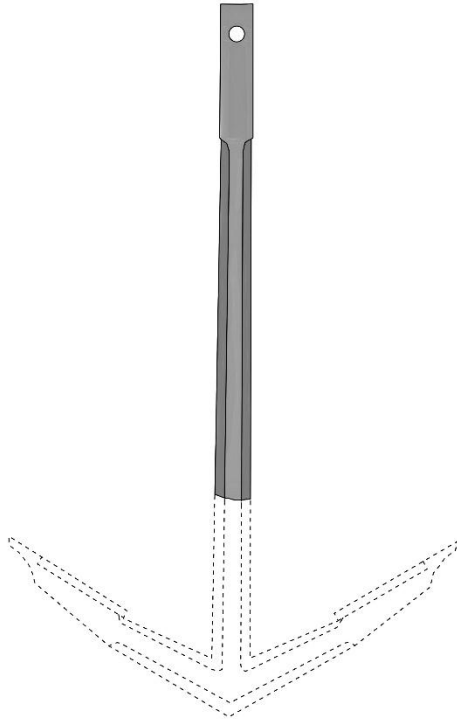
This sketch of an angle-crown anchor (the type carried by *Colossus*) shows the part lying on the seabed shaded and the missing arms and crown dotted. From the dimensions of the iron, it is clear this is too small to be from one of the main (bower) anchors of *Colossus*. It is, however, the correct size to have been the smaller stream anchor. *Colossus* had three bower anchors (18' 6" long), a stream anchor (12' 6") and a kedge anchor (9' 6") when it sank.

If you look at the seabed below the gun you will see a long, slightly bent bar of iron. We did not know what this was until in 2024 we removed all the weed from this bar and it became apparent that it was in fact the shank of a broken iron anchor.

But what is a broken anchor doing here? A search of the surviving logbooks revealed that in 1797, on the eve of the battle of Cape St Vincent, *Colossus* was involved in a collision '*[Culloden] came aboard of us which broke the shank of the stream anchor*' – Masters Log, 12 Feb 1797. This is probably that same anchor shank, stored in the hold and on its way back to England for recycling.

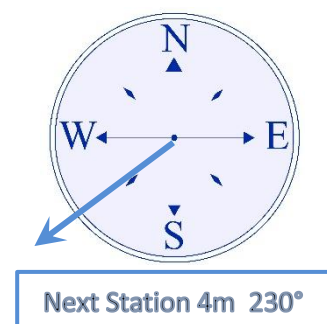
3

Turn to face north. In front of you now is one of the five eighteen-pound iron guns standing upright on the seabed, their muzzles buried in the sand. If you look carefully, you will see that the guns are still within their gun ports. Immediately in front of you there is timber exposed on the seabed. This is the inside face of the ship. You will also see an empty gun port very close to station 3. This is one of the quarter deck gun ports, where smaller nine-pound guns would have been.

Although classed as a 74-gun ship, *Colossus* actually carried 82 guns on four different levels. This was because the convention at the time was to only count the long guns and exclude the eight Carronades on the poop and fore decks. All the guns were smooth-bored cast iron, and designed to fire a variety of projectiles (grape, case, bar, chain and round shot). The guns were classified according to the weight of round shot they fired. The lower gun deck had 28 thirty-two pound guns; the upper deck had 28 eighteen-pound guns while the quarterdeck and forecastle held the 18 nine-pound guns. The guns visible from this dive station are eighteen-pound guns of the Armstrong type, while the lower deck guns were the newer Blomefield 32-pound design.

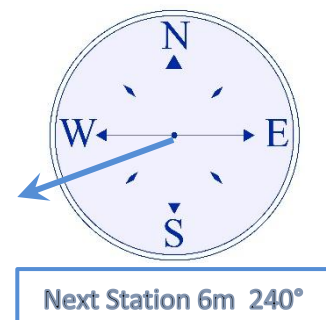
About two metres to the north of station 4 you will find an empty gun port. This gives a clear idea of what the gun ports looked like. Remember you are looking at the inside of the gun port. Notice the corroded iron ring bolts at the side of the gun port, which would have been used to secure the gun carriage to the side of the ship. If you look at the timber on the seabed, you will see the tunnels in the timber created by the wood-boring organisms (ship worm) which are attacking the hull timbers.

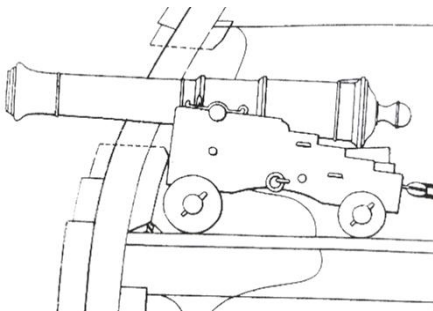
Three metres to the west of station 4 you will find another of the upstanding eighteen-pound guns. Notice a number of iron rods attached to the barrel of the gun. These are the iron fastenings which held the wooden gun carriage together. The timber of the carriage has now decayed, leaving only the remains of the iron fastenings.

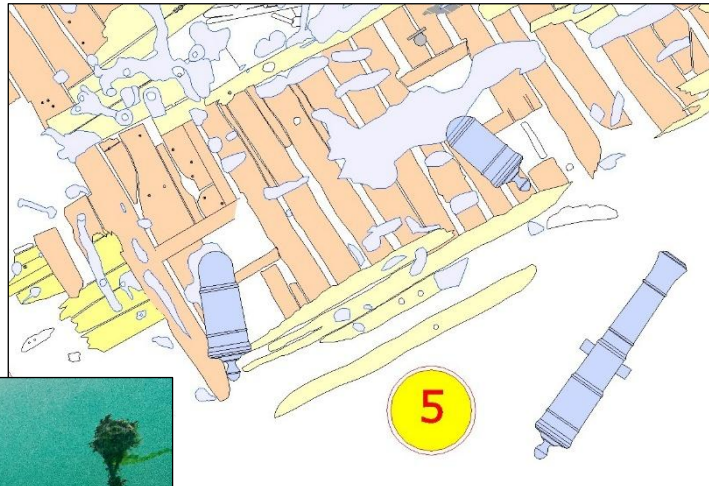
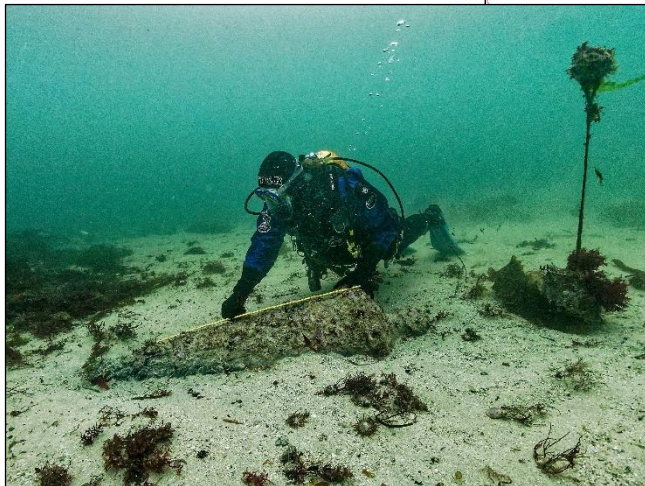
At station 5 you can see one of the eighteen-pound guns lying flat on the seabed. This gun is probably the one which was originally sited at the empty gun port you saw at station 4. Here you can see just how large these guns are. They are 2.75m (9 ft) long and weigh almost two tonnes each. The lower deck guns (thirtytwo-pound) were even larger. We do not know why this gun did not remain within its gunport as the other five eighteen-pounders did.

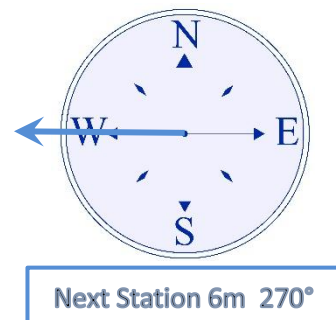
6

You are now at the point where the ship broke in half – roughly where the mainmast was. The bow fragments of the wreck were found over 300m to the west, and were excavated in the 1970's by Roland Morris. He recovered thousands of pieces of ancient Greek pottery (now in the British Museum) which were part of the cargo of *Colossus* when it sank.

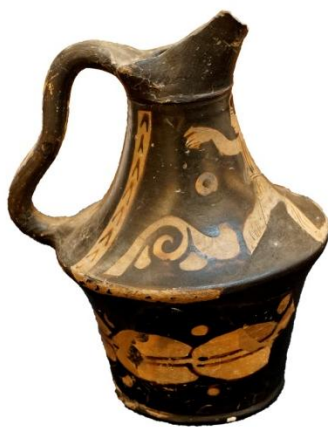
One of Sir William's ancient Greek pots recovered from the wreck of *Colossus* by Roland Morris's divers

Why was a British warship carrying ancient Greek antiquities? Because *Colossus* was in Naples during Nelson's 40<sup>th</sup> birthday celebrations organised by Nelson's mistress Emma Hamilton. The Greek pots belonged to Emma's husband Sir William Hamilton, who wanted to have his valuable collection transported to England. Little did he suspect that they would soon be lying on the seabed in the Isles of Scilly.

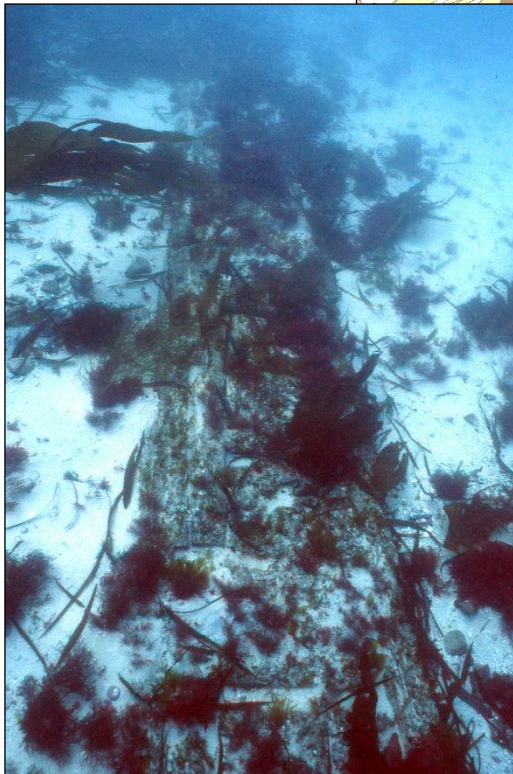
8

Turn so that you are facing south. In front of you are the timbers of the hull. You should also be able to see several copper fastening bolts similar to those you saw at the last station. At the outside of the hull (outer planking) you should be able to see some of the copper sheathing which covered the hull below the water line.

The photograph here shows you roughly what the hull timbers look like at this point (looking east). On the left is the outer hull planking. In the middle, the large square timbers are the frames of the ship. On the right-hand side is the inner planking. If you look carefully, you should be able to see the joins in the planking. Again, you will notice how the timbers are being attacked by wood-boring organisms – sometimes called gribble and shipworm.

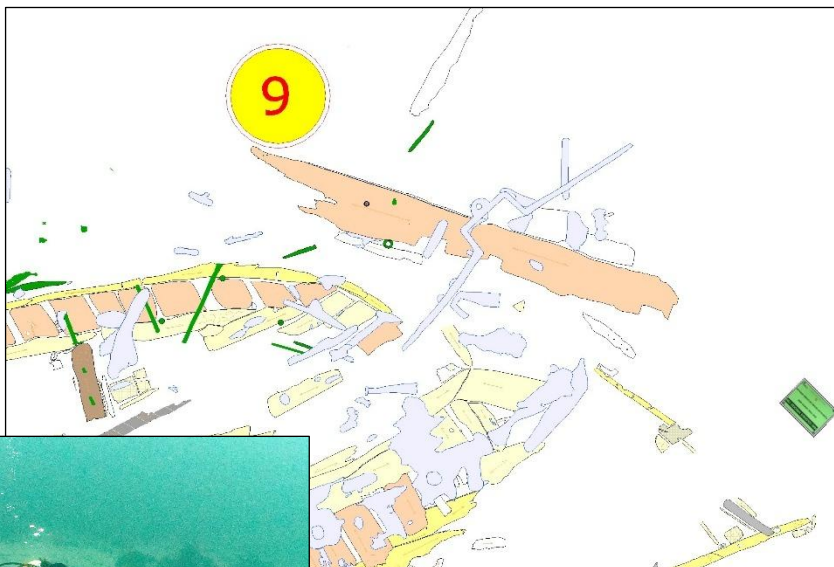
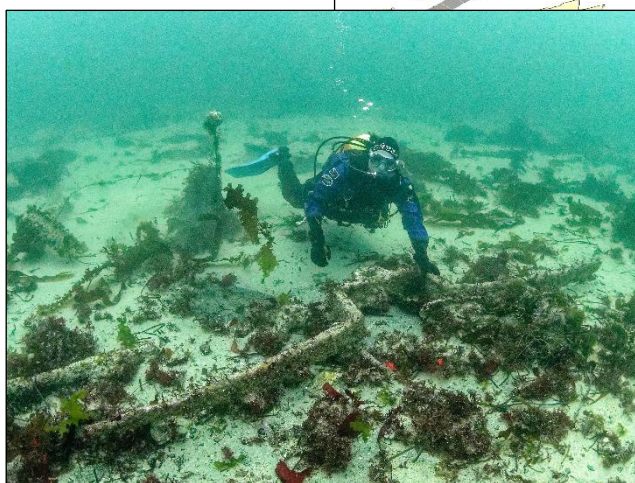
9

Here is part of the stern post of the ship. The large iron object on top of the timber is one of the rudder gudgeons, an iron strap used to attach the rudder to the hull (the gudgeons attach to the hull and the pintols (pin tails) attach to the rudder). The hole in the centre of the gudgeon is where the rudder pivoted on the pintol pin. *Colossus* lost its rudder when it first grounded some 400 metres distance to the west of where you are now.

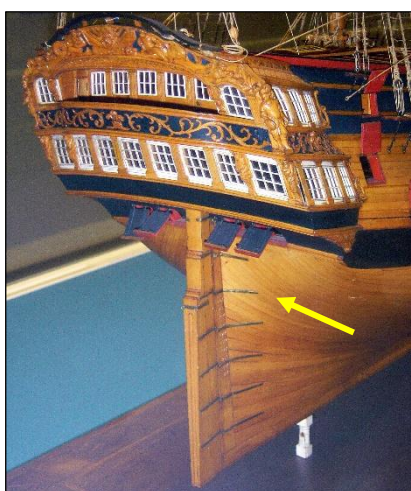
This photograph of the stern of a model of a similar ship shows the position of the rudder gudgeon (arrowed).

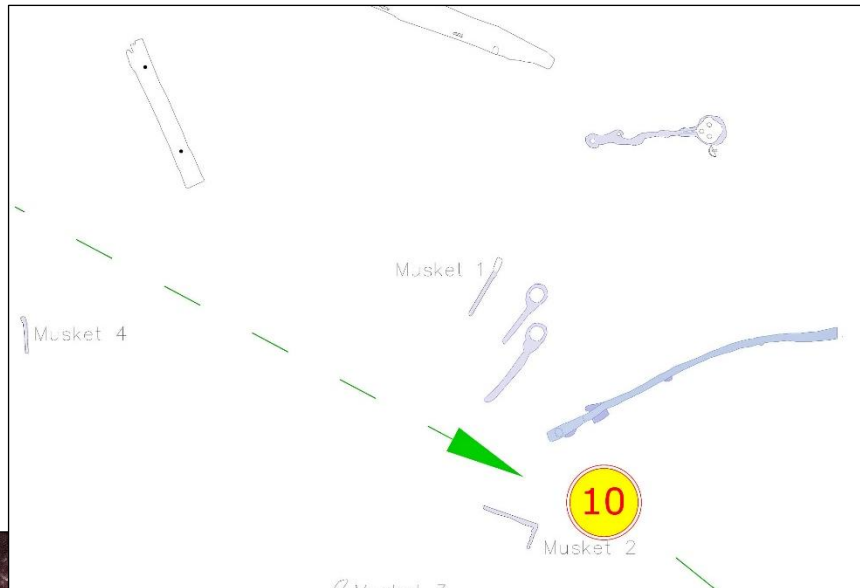
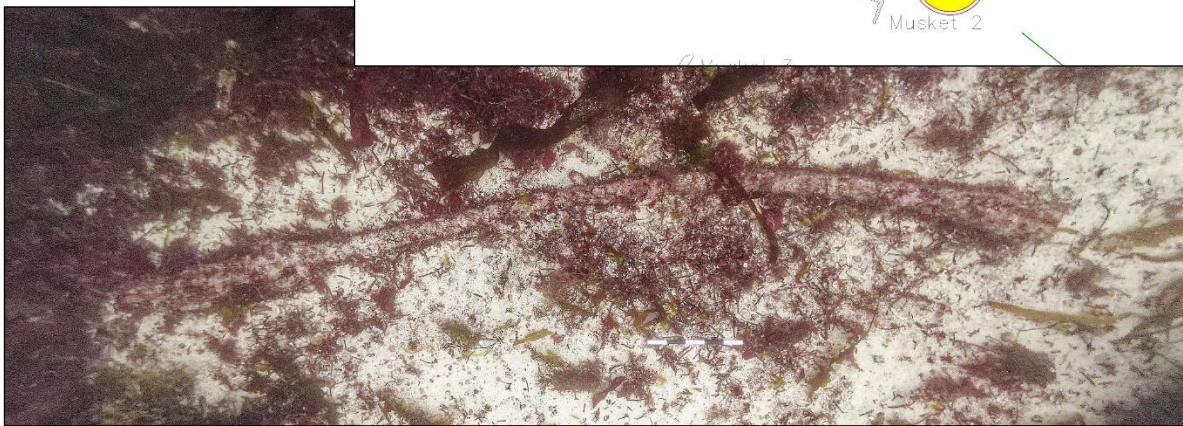
10

You should be looking at a long iron object on the seabed. It is 4.65m (15 ft) long and slightly curved throughout its length. For many years we were not certain what this large iron ‘spar’ was used for – but we now know that it was the emergency tiller for *Colossus*. It could be fitted to the top of the rudder if the normal wooden tiller (which was fitted immediately below the Gunroom ceiling) was damaged or broken. The emergency tiller would be fitted just above the Wardroom deck.

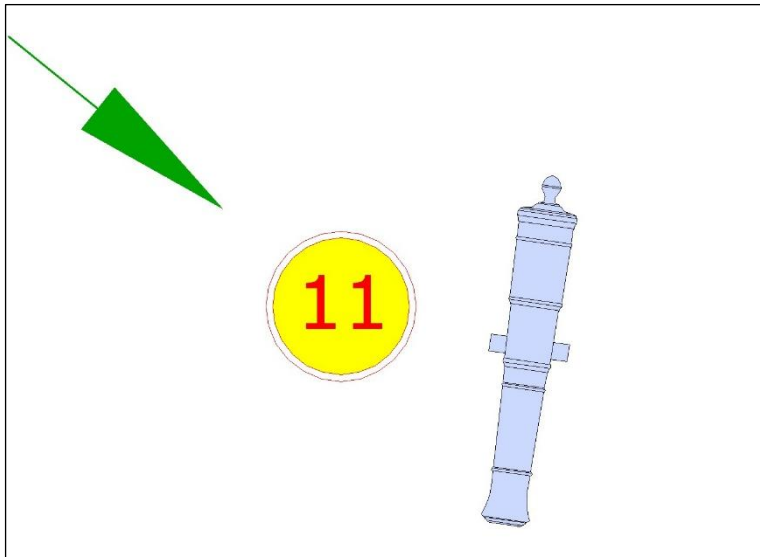
11

At this station you can see one of the Armstrong pattern 9-pound guns from *Colossus*. This is the only 9-pound gun on the site, although there were 18 on *Colossus*. This gun would originally have been on the quarter deck of the ship. Notice that the gun now lies upside down with the iron fastening bolts of the wooden gun carriage still attached to the gun. It is 2.35m (7ft 6 in) long and weighs over a tonne.

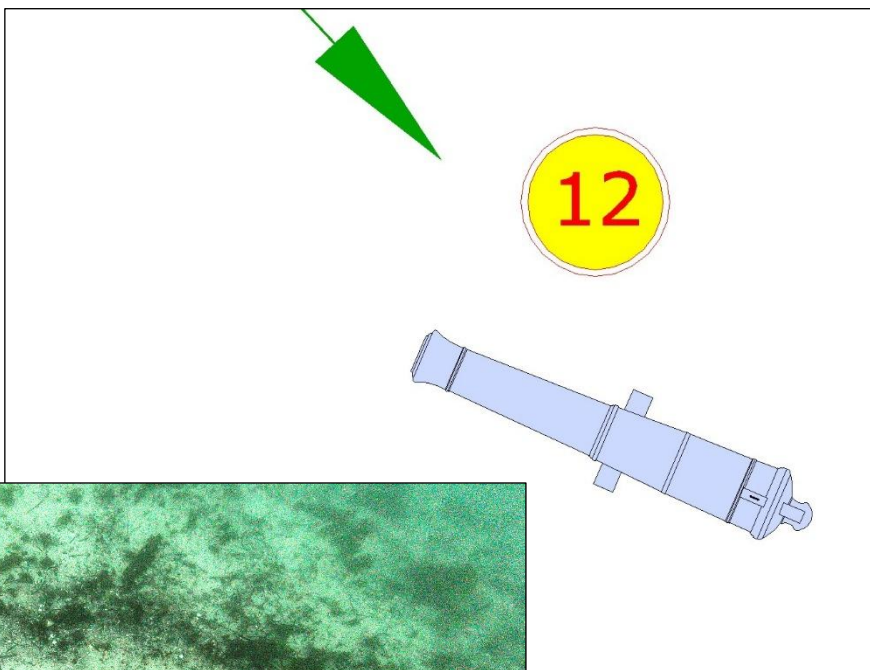
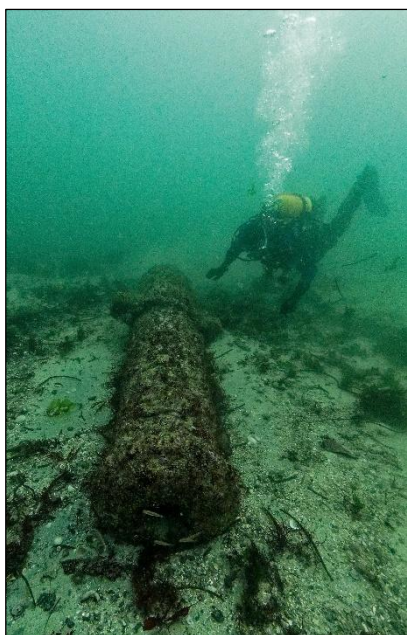
12

At this station you can see one of the Blomefield pattern 32-pound guns from *Colossus*. This gun would originally have been on the main gun deck of the ship. Notice that the gun now lies upside down with traces of iron chain wrapped around the middle of the barrel of the gun. This gun is 2.95m (9ft 6in) long and weighs over two tonnes.

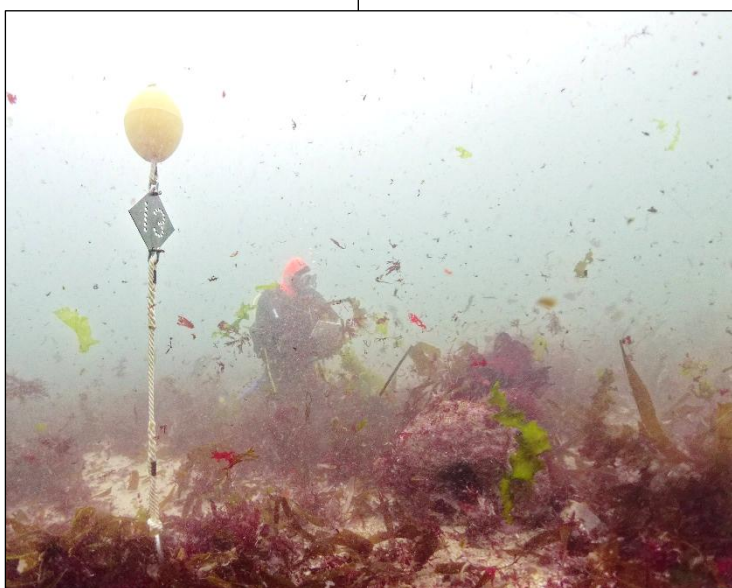
13

You have now reached the final station on the *Colossus* diver trail. This is another of the large 32-pound guns which formed the main armament of the ship. There were 28 of these guns, all on the main gun deck (14 on each side of the ship). The crew also ate and slept on this deck. You may have noticed that several of the guns you have seen have long thin fins running lengthways along their barrels. These form on the surface of the gun as it corrodes on the seabed, and indicate the location of a crack in the cast iron of the gun.
